Research on Eddy Current Testing Technology of Bimetallic Composite Pipes

The eddy current testing study was conducted for the surface defects of bimetallic composite pipe 360QS/825 nickel-based alloy lining, and the eddy current testing model was designed using ANSYS Maxwell finite element software to simulate and analyze the response of the coil probe with different excitation frequencies to the corrosion defects. The simulation results show that when the excitation frequency of the probe is increased, the change of magnetic induction intensity at the defect also increases, which confirms that increasing the excitation frequency helps to increase the resolution of the coil. At the same time, eddy current testing experiments are conducted for bimetallic composite pipes, and the relationship between bimetallic composite pipe lining defects and weld seams and signals is verified through experimental analysis. The preliminary quantification of pipe defects, is achieved in this paper.

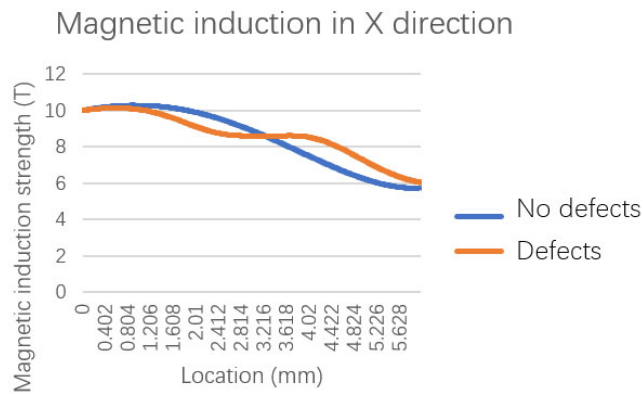
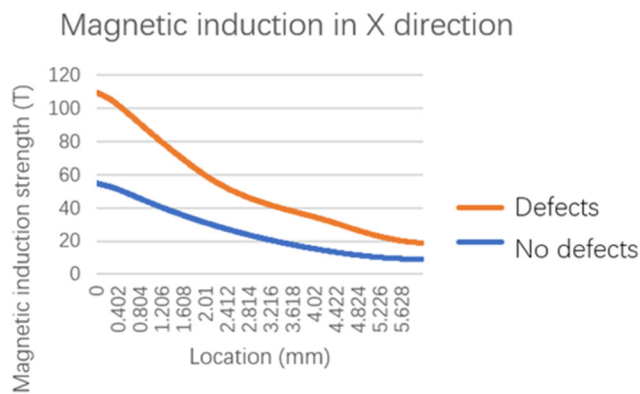
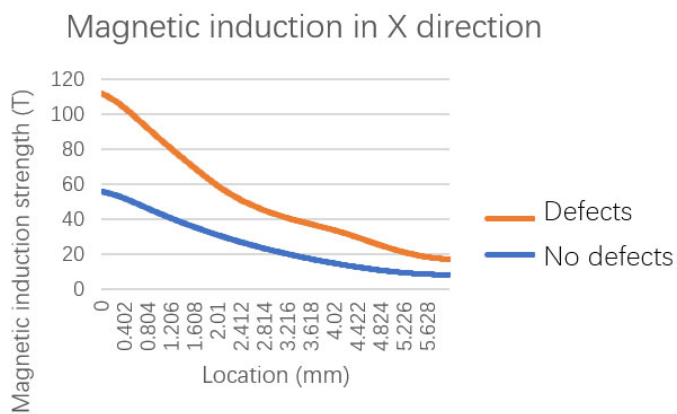
The magnetic induction intensity of the defect surface was simulated and analyzed. The magnetic induction intensity curves generated by the excitation coil when detecting pipe defects at excitation frequencies of 300 kHz, 600 kHz and 1 MHz are shown in Figure 4.

(a) Variation curve of magnetic induction intensity with coil at 300kHz excitation frequency

(b) Variation curve of magnetic induction intensity with coil at 600kHz excitation frequency

(c) Variation curve of magnetic induction intensity with coil at 1MHz excitation frequency

Figure 4. Variation curve of magnetic induction intensity under different excitation frequencies

As can be seen from Figure 4, the variation range of the magnetic induction intensity at the defect location increases with the increase of the probe excitation frequency while keeping the number of turns of the coil probe, the detection distance, and the inner and outer diameters

constant. Therefore, the resolution of the coil can be optimized by increasing the excitation frequency of the sensor probe, provided that the above conditions remain unchanged.

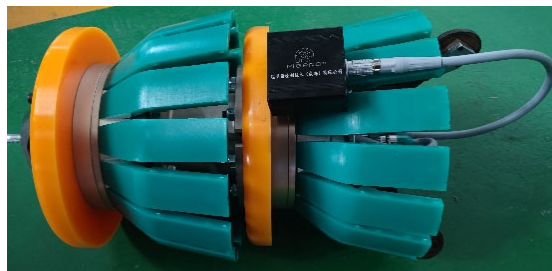
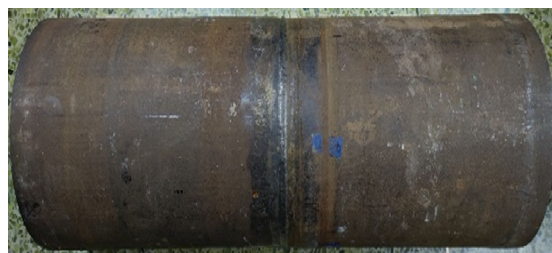
From the simulation results, it can be seen that the lining defect signal is more easily detected when the excitation frequency is set above 600 kHz. Therefore, this testing device uses a clear pipe eddy current detection device with excitation frequency set at 1 mHz, and the test sample is a bimetallic composite pipe with an outer diameter of 325 mm, an inner diameter of 295 mm, a length of 1 m, a carbon steel base pipe thickness of 12 mm, and an 360QS/825 nickel-based alloy lining thickness of 3 mm, as shown in Figure 5.

(a) Eddy current detection device

(b) 360QS/825 bimetallic composite pipe

Figure 5. Detection device and bimetallic composite pipe

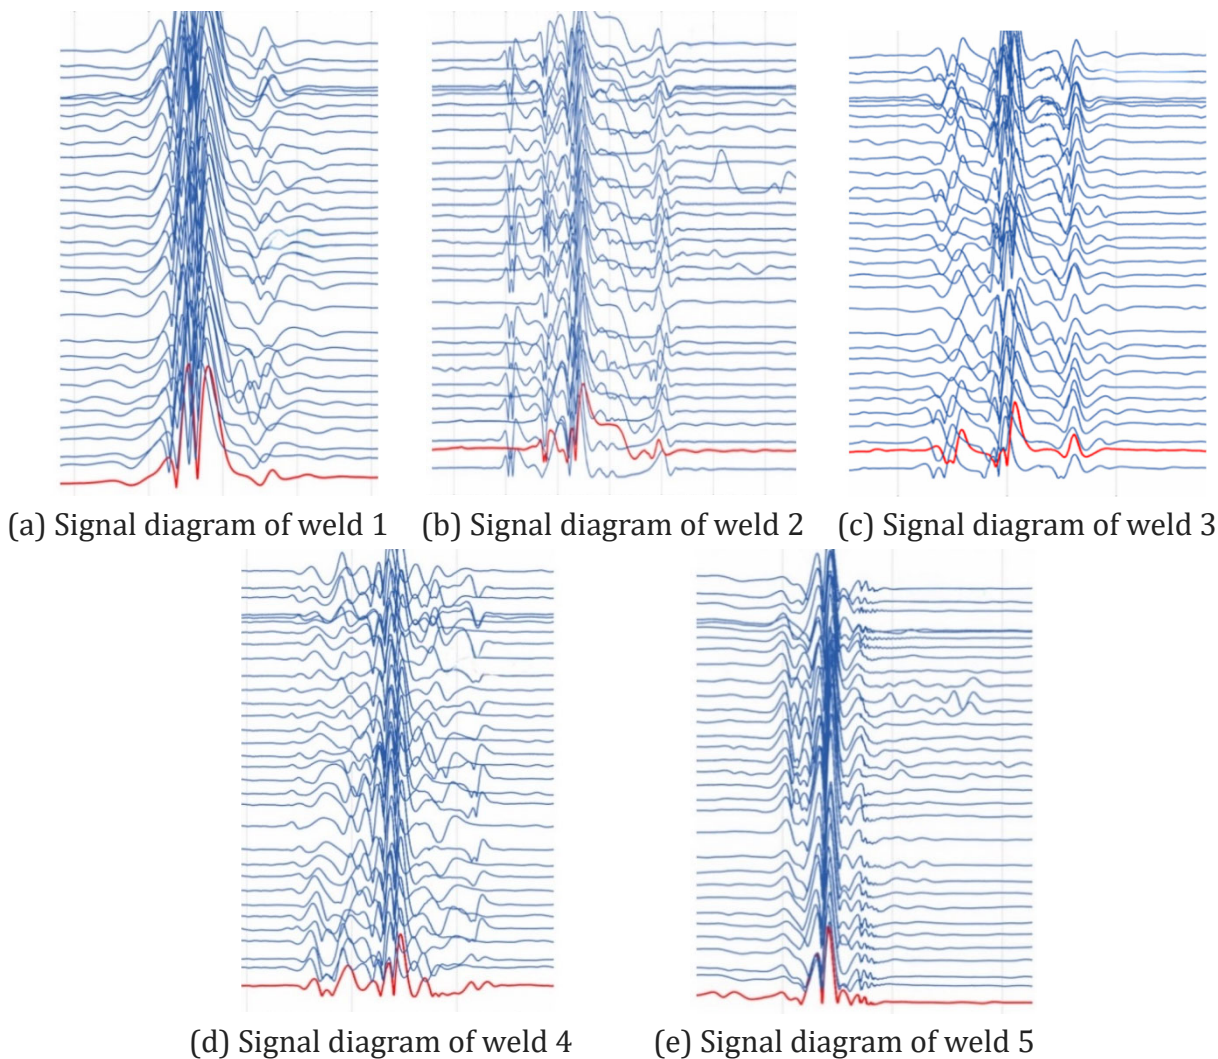
The pulse eddy current detection device is drawn, and the signal at the bimetallic composite pipe weld is shown in Figure 7.

Figure 7. Weld signal diagram

As can be seen from Figure 7 and Figure 8, the signal characteristics of the bimetallic composite pipe weld and lining defects are clearly visible under the condition that the excitation frequency is 1MHz, and the eddy current detection of defects of different shapes and sizes can accurately determine their locations.
