Design of Large Cantilever Structure of Independent Column

Abstract

This project is based on the original stand of China University of Geosciences Stadium. First, the original concrete canopy is removed, and then a steel structure canopy is added to the stand. The overall structure adopts a steel pipe truss structure, and the roof maintenance material adopts a single-layer reticulated shell supporting membrane structure. This structure is a large cantilevered structure with independent columns. In order to reduce the vertical displacement of the canopy structure, the vertical and horizontal truss structure is adopted, and the double-column joint foundation form is adopted to improve the overall stability of the structure. According to the bearing capacity requirements of the whole structure under the action of wind load and other live loads, the force analysis of the structural members is carried out, including the analysis of the overall vertical deformation of the structure, the stress analysis, and the force analysis under the action of earthquakes. This structure is a large cantilevered independent column structure, and the stability control of the overall structure must meet

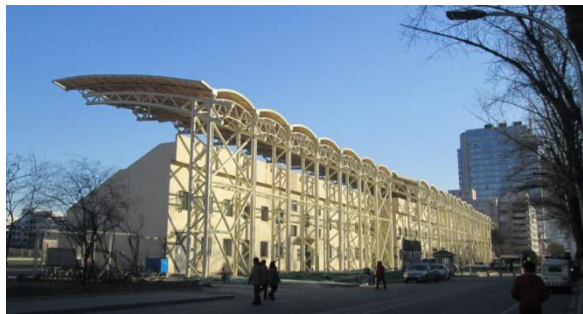
China University of Geosciences is located on Xueyuan Road, Haidian District, Beijing, where famous schools gather. It is a well-known institution of higher learning at home and abroad. This project is the structural design of the new canopy for the playground stand of China University of Geosciences. Figure 1 shows the stand canopy that has been constructed.

Figure 1. Stadium grandstand canopy

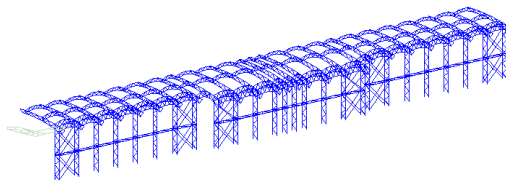
The main structure of the new stand canopy adopts a steel pipe truss structure, which is composed of a horizontal truss, a longitudinal truss, an inter-column support and a roof support to form a spatial structure system. The transverse truss adopts double-limb lattice beams and columns, each of which is connected by longitudinal trusses, and each group of lattice columns is connected by horizontal trusses. The maximum cantilever length of the transverse truss is about 15 meters. In the middle part of the canopy, the span of the transverse trusses on both sides is about 12 meters, and the whole is a symmetrical structure; section. The roof maintenance material adopts a single-layer lattice shell supporting membrane structure. The overall model of the canopy is shown in Figure 2, and the single-product truss structure is shown in Figure 3.

Figure 2. Integral model of Stadium Canopy

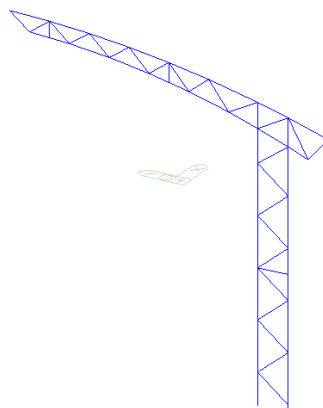
Figure 3. Cantilever single truss model

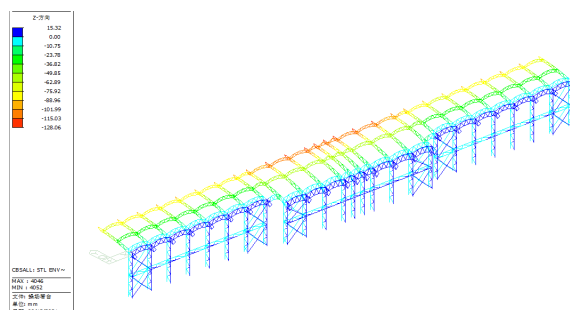
Under the action of the standard combination, the maximum vertical deformation of the whole structure occurs at the position of the maximum span in the middle, as shown in Figure 4. The maximum cantilever length is about 15m, and the maximum vertical deformation value is 128mm, so the deformation/span=128/15000x2=1/234<[1/150], and the vertical displacement meets the specification requirements.

Figure 4. Vertical displacement diagram of canopy

(2) According to the overall deformation analysis of the structure, the maximum vertical deformation of the canopy is less than 1/150, which meets the requirements of the specification.

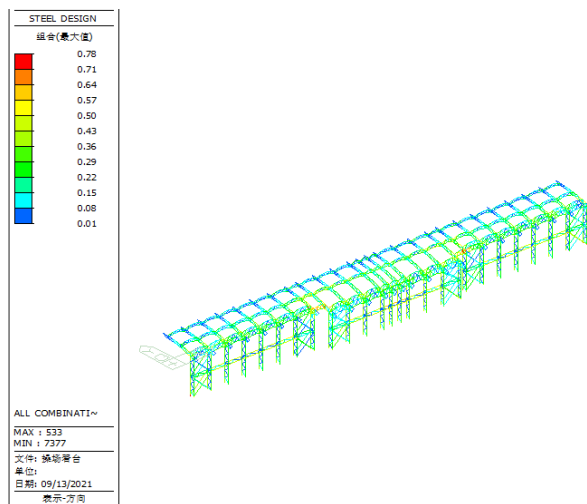
The overall stress ratio of the structure is shown in Figure 5. It can be seen that the stress ratio of all rods is below 0.8, and the bearing capacity meets the requirements, indicating that the canopy structure has a significant spatial effect, good stability, and overall safety.

Figure 5. Overall stress ratio of canopy

(1) According to the analysis results of the static model, it can be seen that the normal section strength, stress and stiffness of the structure all meet the requirements of the specification, and there is a certain safety reserve.

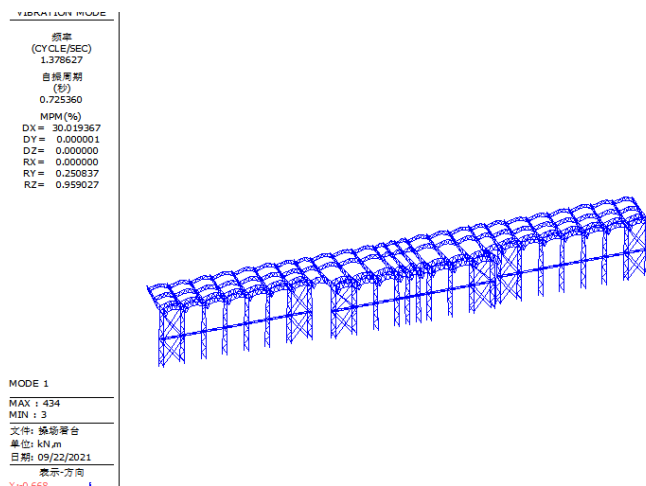
The overall natural vibration period of the canopy is shown in Figure 6. It can be seen that the natural vibration period of the canopy dominated by vertical vibration is less than 1.0s, indicating that the vertical stiffness is good.

Figure 6. Overall natural vibration period of canopy

(3) From the results of the seismic analysis model, it can be seen that the natural vibration period of the canopy, which is dominated by vertical vibration, is less than 1.0s, which meets the requirements of the specification.

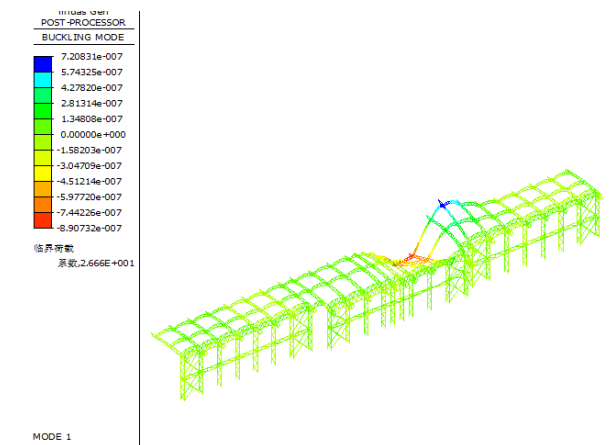
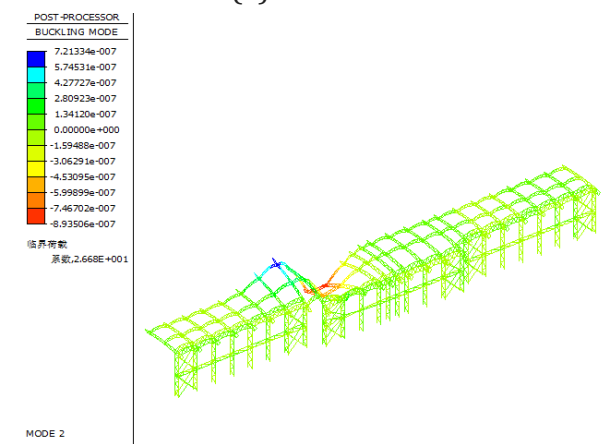
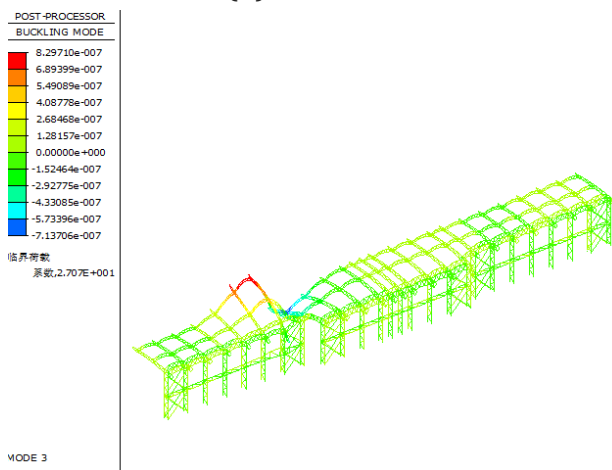
This analysis only considers the linear buckling mode, which is an ideal state for the structure, so there is a certain deviation, it is only used to improve the structure, and its vertical front six-order buckling mode is obtained under the action of gravity and live load. As shown in Figure 7.

(a) 1st Model

(b) 2nd Model

(c) 3rd Model

Figure 7. Buckling mode diagram

According to this buckling analysis, the critical load coefficient under each order buckling model, that is, the eigenvalue coefficient, is obtained. The buckling of each stage occurs at the position of the roof transverse truss rod, and every two order buckling modes are symmetrically distributed. The stability of this structure is analyzed from the buckling coefficient in Table 2.1. It can be seen that the stability coefficient of the structure is far greater than 4~5, so the overall instability of the structure will not occur when the load is normally used.

Buckling Model	Buckling Factor	Buckling Shape
1	26.67	Vertical bucking
2	26.68	Vertical bucking
3	27.07	Vertical bucking
4	27.16	Vertical bucking
5	29.86	Vertical bucking
6	29.87	Vertical bucking

(4) It can be seen from the results of the buckling analysis model that the stability coefficient of the structure is much larger than 4~5, and the overall instability problem of the structure will not occur when the load is normally used.
